Post Flood Damage Assessment Study in Balochistan Province - Nari and Porali River Basins

**Balochistan Integrated Water Resources Management
and Development (BIWRMDP)**

Draft Study Final Report

December 2022

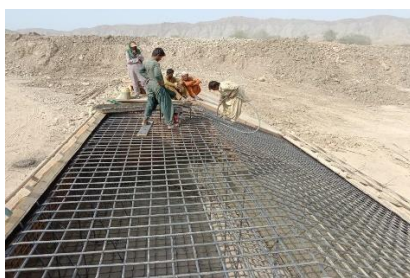
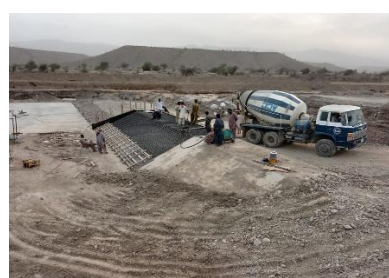
Construction of Main Weir at Shab-e-Maidan

Package 1 has Main Weir and Main Channel; the Main Channel (3,575 m) sustained slight damage across 200 m of its earthen portion, however there are no damages in the channels of Package 2. The main weir (under construction) was also safe and no damage has been observed. Under Package 1 there are separate head regulators for flood and perennial channels. The main weir is broad crested with a length of 100 m and discharge estimated at 367 cum against a 50 year return period flow. The flood channel has a length of 3,575 m with a command area of 1,200 ac. The perennial channel has a length of 2,500 m with a command area of 300 ac. Work on the main weir, main channel and fall structures is currently in progress.

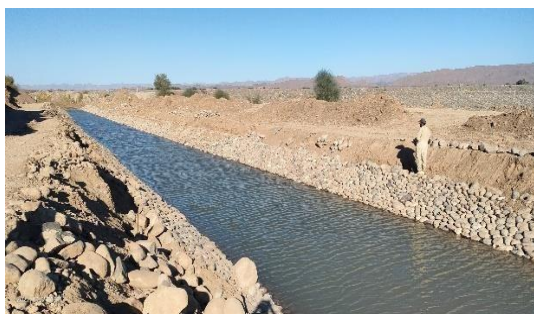
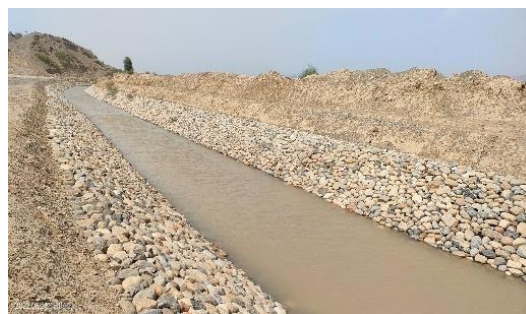
Gundacha Channel---Pre Flood

Gundacha irrigation scheme has been shown previously in **Figures 1 and 2**. Under Package 1, the scheme comprises the main Gundacha channel with a head regulator of discharge 05 cumecs. Other two main channels of Bhit and Jamoot are also of the same capacity. Pero channel is protected by a 3,075 m long embankment, followed by Sardarwala 1 at 1,925 m and Sardarwala 2 at 1,125 m. The Bhit Channel head regulator (under construction with reported 20 to 25% physical progress) has sustained damages to the Low Head Weir cutoff walls. Jamoot head regulator has lost its right side cutoff wall. Whereas it was observed that, the completed Gundacha head regulator has safely passed the flood flow and remained intact.

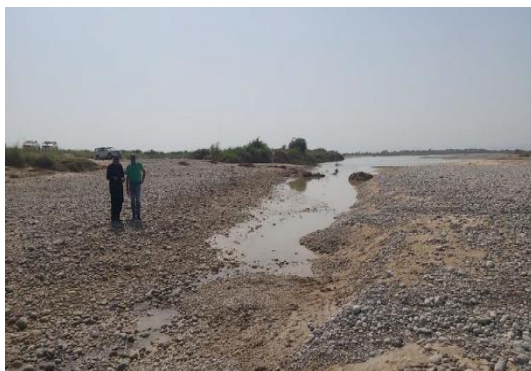
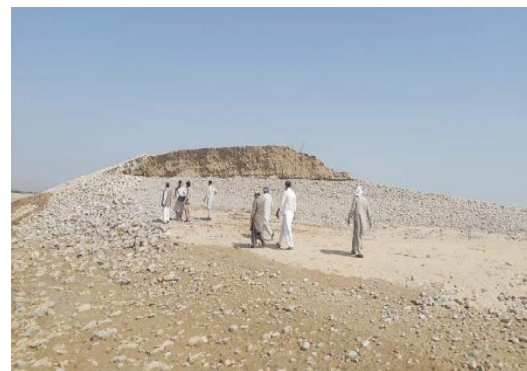
Inspection of the 890 m length of the FP Bund by the Study Consultants indicated a 350 m portion as a washout (**Figure 7**).

Bakhra Ghulam Bolak Bund showing completely washed out portion (Approx 350M)

The protection works were damaged due to unprecedented and excessive discharge in the main Nari Gorge over and above the design allowance. The bund was designed for 100 k cusec whereas monitored flood flow was 240 k cusec.

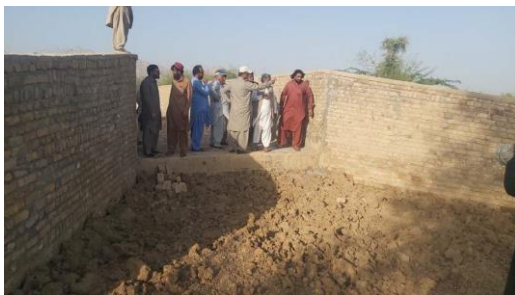
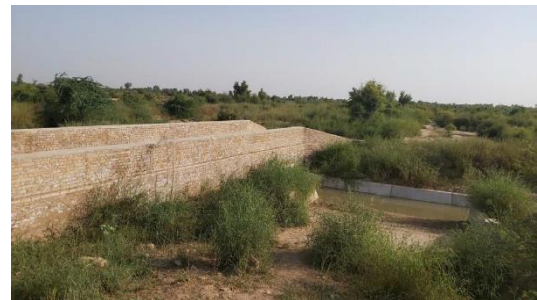
Super passages in Package-2 Irrigation Scheme

A few of the 17 Super Passages, constructed under this package, were inspected and some insignificant damages were observed to masonry work and approaches.

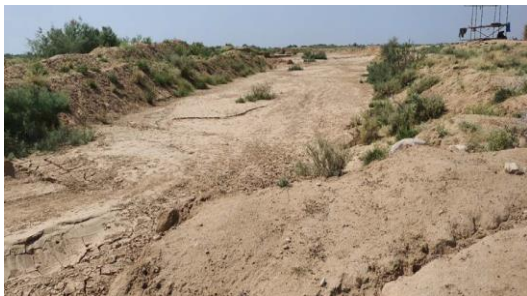
Inspection of the Arrand Channel was made along both sides and no damages were found between Structure 1 and Structure 2. The concrete head structure of the channel was also safe with no major flood damage.

Arrand flood irrigation channel under Package 3

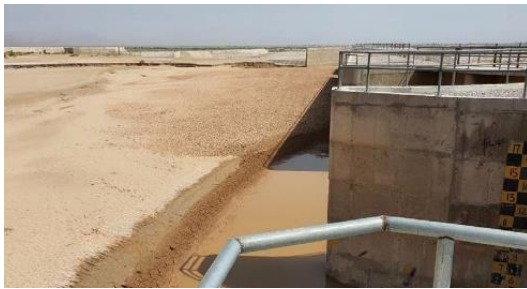
The general post-flood condition of the structures is satisfactory; however, the clear watermarks on the piers of main weir had evidence of overtopping the structure during Flood-2022. The observation was strengthened by the presence of trash/straws on top of the main structure.

Visible water-marks on the Pier showing overtopping

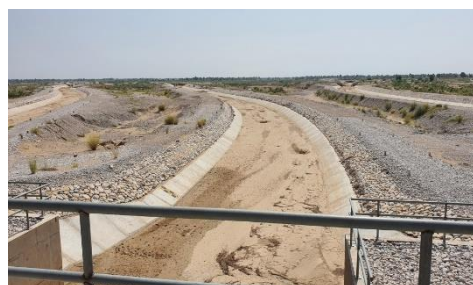
Channel Siltation at Mushkaf Irrigation Scheme

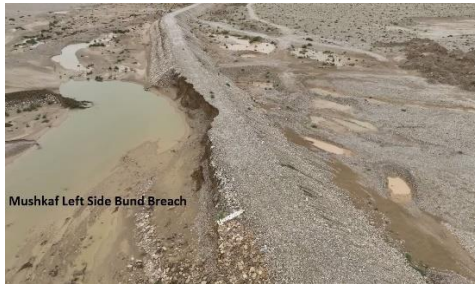
Left side guide bund was found damaged to a length of 100 meters however it was noticed that this bund was constructed by the Irrigation Department during past and it was only raised during BIWRMDP and the damaged portion was found to be filled with fresh earthwork at site. Initially, the Consultants reported the left side guide bund as a “breach” in the Initial Report that was filled and restored; however, a photo of the damaged site was subsequently showed accessed through secondary records that revealed the left side guide bund to be heavily eroded due to presence of an old spur in front of the

affected portion. The serious erosive action badly damaged the bund but did not entirely breach the section.

Erosion but no breaching of the left guide bund

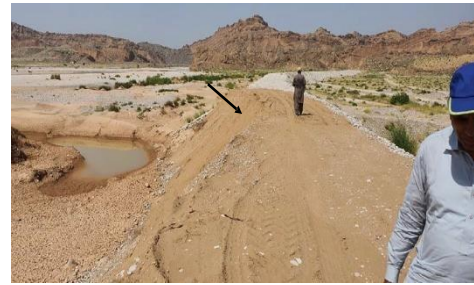
Damaged section repaired

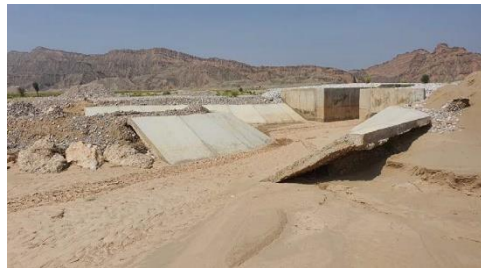
Damage to the earthwork filling behind concrete canal lining was also observed on the structures of distribution channels that would require replacement.

Damaged canal lining

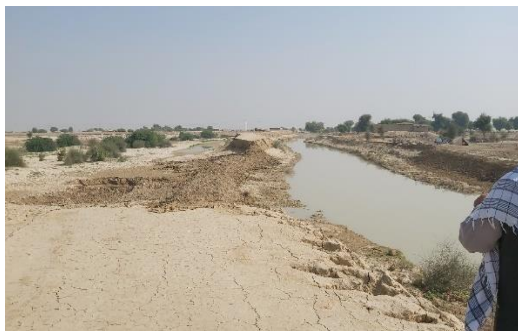
Site observations showed cracks on top and sloping portions of the embankments due to heavy rainfall. There were eroded banks in small patches that are likely the result of wave action of flood water along the embankment. Within the constructed reach, a portion of 60-80 meters was found washed-out. It was told that the local inhabitants made a relief cut in the embankment in a desperate pursuit of saving their houses and animals. The washed out portion could be seen in the photograph.

**Relief cut in the Embankment of
Tariqabad FP Bund**

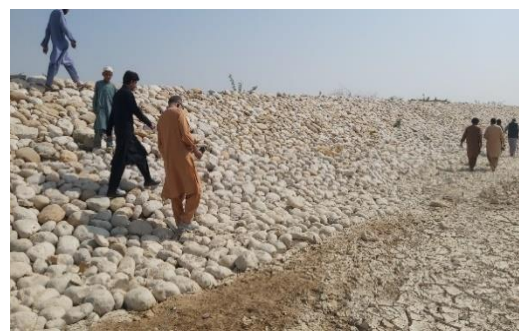
**Stone pitching work suspended due
to quality issues**

During inspection, a completed 100 m section of stone pitching was also where no further activity was noticed due to work suspension prior to flooding. BIWRMDP Officers informed that the pitching work was suspended prior to the flood due to undersized stone. No significant loss of stone pitching work was observed in the observed reach.
