Post Flood Damage Assessment Study in Balochistan Province - Nari and Porali River Basins

**Balochistan Integrated Water Resources Management
and Development (BIWRMDP)**

Draft Study Final Report

December 2022

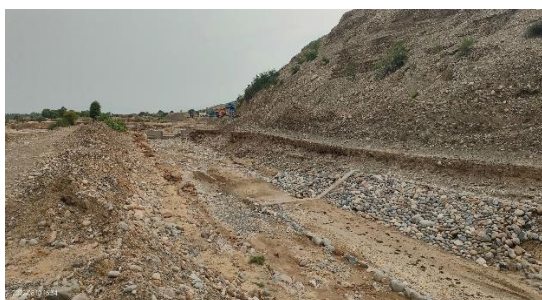
Gundacha Channel---Post Flood

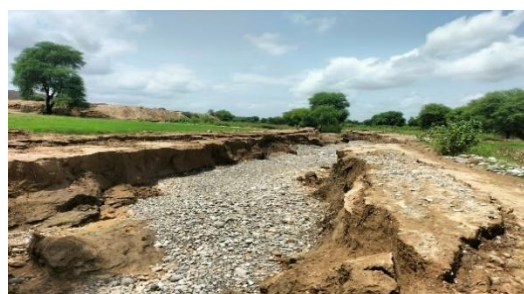
Bhit Channel---Post Flood

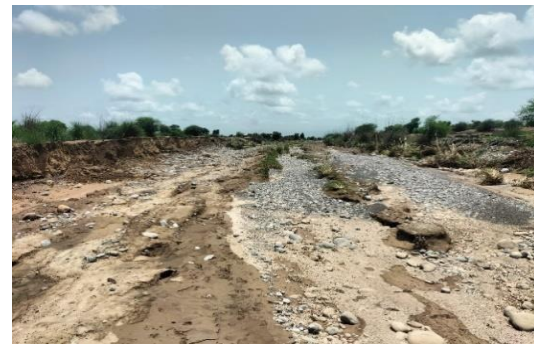
Jamoot Channel---Post Flood

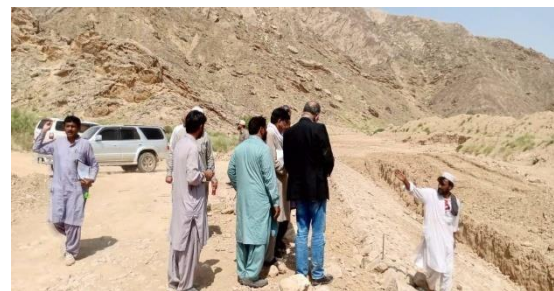
On-going work of stone pitching at Arrand Channel

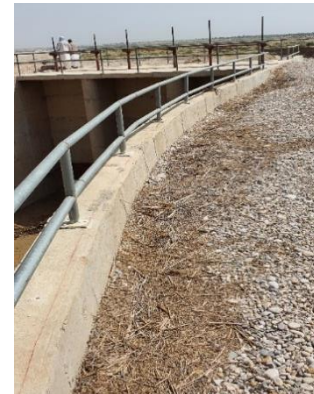
The general post-flood condition of the structures is satisfactory; however, the clear watermarks on the piers of main weir had evidence of overtopping the structure during Flood-2022. The observation was strengthened by the presence of trash/straws on top of the main structure.

Trash/straws on the top surface of the main structure

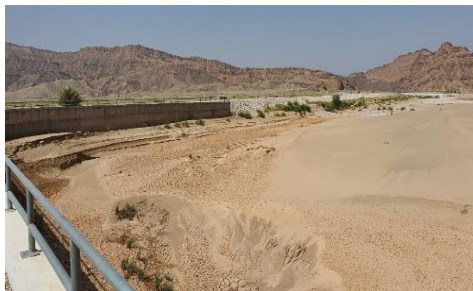
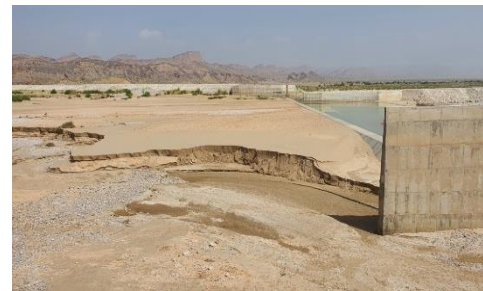
During inspection visits in November, the Consultants were informed that during the flood peak experienced on July 14, 2022 the local inhabitants/irrigators forcibly took control of the spate regulation in the presence of Irrigation Staff and the law-enforcing agencies. Not only did they abruptly open the gates of their respective head regulators in disregard to operating rules but also kept the gates of “undersluices” closed to allow for maximum inflows into their channels. Their action led to huge deposition on both the upstream and downstream sides of the weir. Moreover, silt laden flood water entry into irrigation channels caused massive siltation and erosion of the side banks.

Weir Siltation at Mushkaf Flood Irrigation Scheme
